PLANT SOCIOLOGY

Volume 54 (1) - Suppl. 1 - June 2017

Bridging nature and human priorities in ecological rehabilitation projects - a show case from Mediterranean environment - Qattine, Lebanon

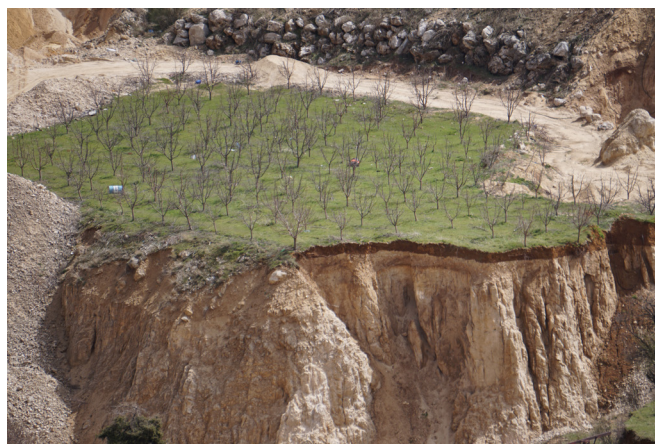
Fig. 1 - Amez, Lebanon - example of common rehabilitation practices in Lebanon, where abandoned quarry sites are used for agriculture.

These practices are generally implemented with a minimal budget aiming to free the financial reserve (134,000 USD), with a low financial investment and inexistent monitoring efforts. They are carried out with little or no consideration for the biodiversity and ecological dynamics of the site (Fig. 1).

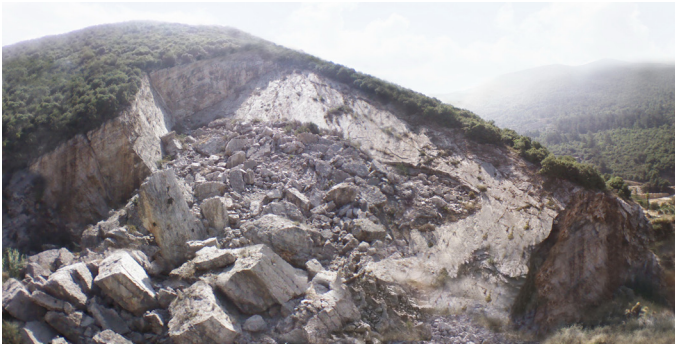
Fig. 2 - Aerial view of the Qattine quarry.

This paper deals with the case study of an abandoned quarry located in Qattine, Keserwan – Lebanon (Fig. 2) and argues that it is possible to design a rehabilitation plan based on the ecological attributes of a site and building on the existing and potential biodiversity while serving human aspiration for future use of the site and acknowledging the ecological, economic, financial, and social challenges. As the site falls on private property the political interference has a minimal impact in this case.

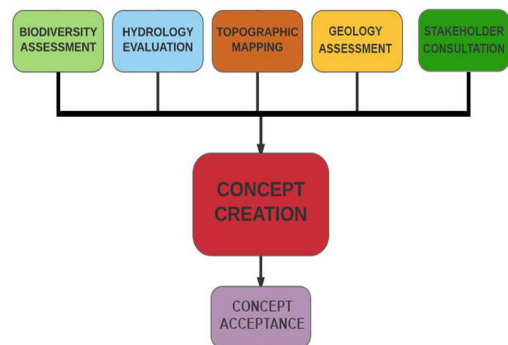
Fig. 5 - Methodological scheme resuming the baseline assessment towards the development of the rehabilitation concept (Khater, 2015)

The concept for rehabilitation was derived from the methodological scheme detailed in Fig. 5 hereafter.

The baseline assessment (Fig. 5) covers ecological screening, biodiversity assessment, and geology, hydrology and topographic mapping of the site and its direct surroundings. It enables us to identify the sites' potentialities in order to overcome its challenges.

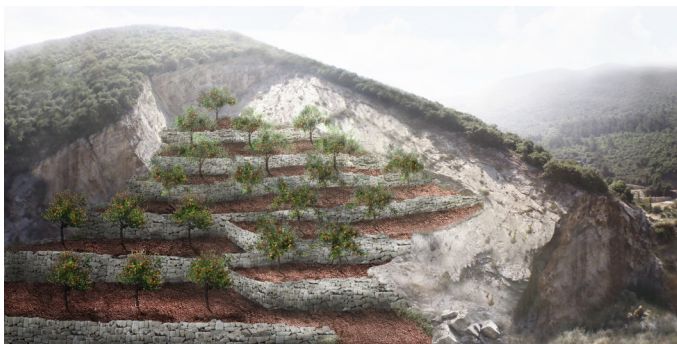
Fig. 6 - Reconstructed scenario of classical rehabilitation in terraces and orchards plantation as expressed by the site’s owners.

Meetings with stakeholders allowed to identify that initial stakeholder's perception for the site meets the traditional common rehabilitation practices consisting of removing the fallen rocks and using them to build terraces, adding agricultural soil and planting some apple trees as shown in the reconstructed scenario (Fig. 6).

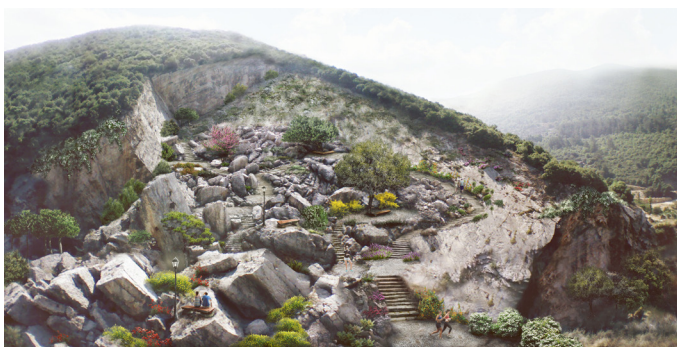
Fig. 7 - ‘Across the Wild Rocks’ rehabilitation concept - developed for the Qattine quarry as a meeting point between ecological priorities and future human use.

The "Across the Wild Rocks" rehabilitation concept (Fig. 7) presented in this paper was inspired from the story of the site and the observation of existing and potential biodiversity.

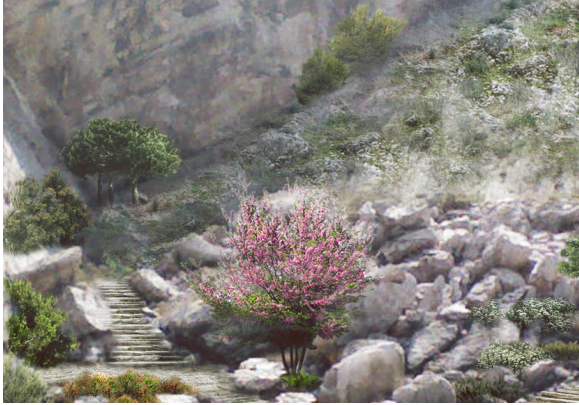
Fig. 8 - Close ups views on the enclosed natural gardens conceived to enhance existing biodiversity and promote natural dynamics.

The concept is designed in such a way as to blend in the surrounding geomorphology and scenic landscape, while diversifying landforms to host a greater number of animals and plants (Fig. 8).

The pockets will be drilled in different sizes and different locations across the quarry face, which will allow the site to host wildlife again.

The pockets on the mirror fault will be a few centimetres wider and their cavity would be filled with soil containing seeds collected from the site's surroundings.
